Technical Report 506

**PLANTINGS OF RED MANGROVES
(*Rhizophora Mangle* L.) FOR
STABILIZATION OF MARL SHORELINES
IN THE FLORIDA KEYS**

1 February 1980

Final Report: July 1977 — May 1979

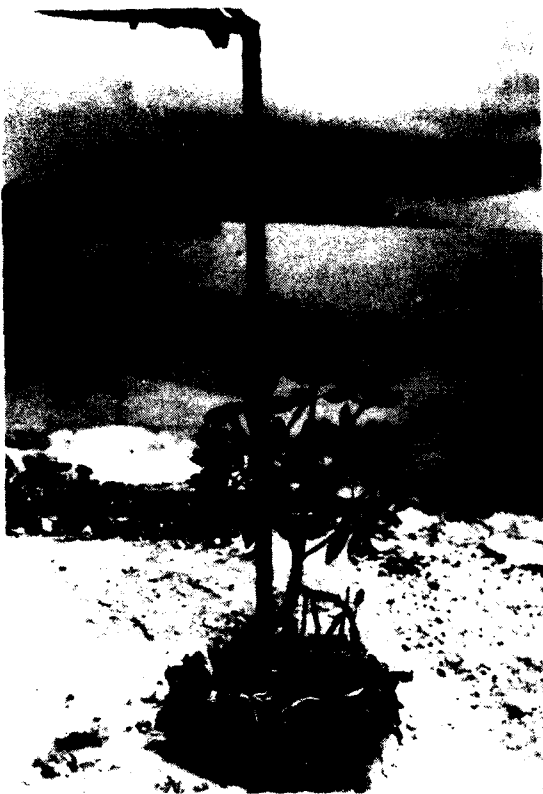
Figure 2. Typical small mangrove tree (Type C) used as transplant stock.

TYPE C. Small mangrove trees possessing aerial prop roots (approximately 2-3 years old) were collected at the same location and in the same manner as Type B plants but with minor differences. Type C plants were removed with a root ball diameter corresponding to the leaf drip line and were transported to the transplant site without the use of nursery pots. The Type C mangrove trees were 0.4-0.8 m tall (\bar{x} = 0.56), had 1-7 aerial prop roots (\bar{x} = 3.3), and root ball diameters that ranged from 25-50 percent of the tree height (Figure 2).

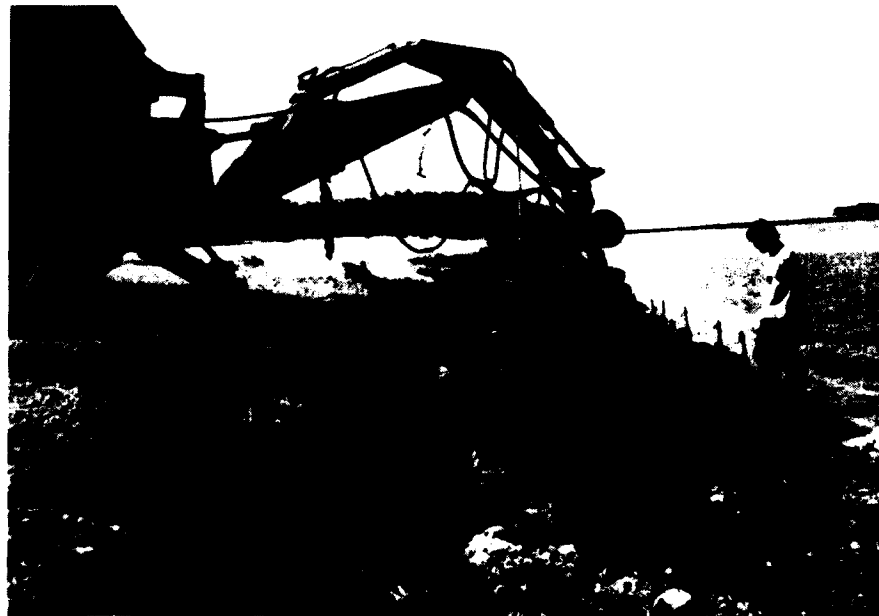
Figure 4. Power auger used to bore transplant holes (Site B).

A hydraulic power auger and operator were rented (@ \$25/hr) to bore transplant holes into the packed marl substrate at the three sites (Figure 4). Beyond the obvious economic and time saving advantages of a power auger, it was thought that the loosening of the packed marl in the area adjacent to the hole may improve the free exchange of seawater and prevent the formation of a subsurface hypersaline condition. Forty-two holes at each site (i.e., a total of 126), 0.41 m (16 in) in diameter and 0.45–0.61 m (18–24 in) deep, were bored at a cost of \$1.00/hole. Boring and planting operations were accomplished during daytime low tides of –0.1 m (–0.3 ft) MLW which provided optimal working conditions (Figure 5). The loose marl removed from the augered holes was shoveled into a wheelbarrow and mixed 50:50 with one of two organic amendments (i.e., peat or seagrass wrack). Mangrove plants were then placed in the holes along with the marl:organic mixture and secured with bailing wire to a 1 m section of construction rod that was driven into the substrate immediately adjacent to the plant (Figure 6). A metal identification tag with coded treatment information was also attached to each plant. Transplants were made according to an experimental design which distributed the transplant treatments (i.e., developmental stages, tidal heights, and organic amendments) in a regular repeating triplet arrangement at each site. This arrangement was designed to minimize the effect of any within-site variation.

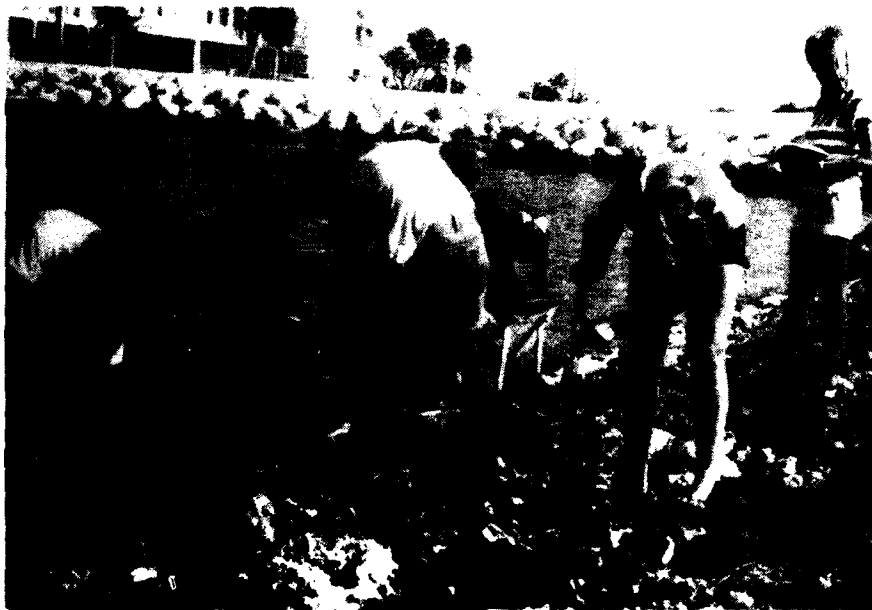
Figure 5. Transplant crew working during low tide conditions (Site B).
